# New life for old conveyor pulleys

Pulleys are designed to last, but can suffer damage from wear over time. Thomas Greaves, General Manager of Dyna Engineering, discusses when you should refurb rather than replace.

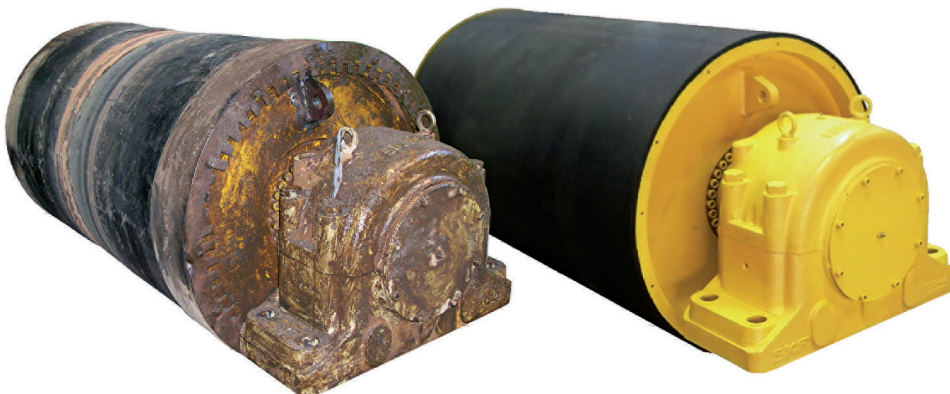
*Pulley before and after DYNA's refurbishment.*

Regular maintenance of conveyor equipment, including pulleys, is essential to reducing wear rate and prolonging service life. Reconditioning or refurbishing the pulley will help avoid the excessive cost of a complete pulley replacement.

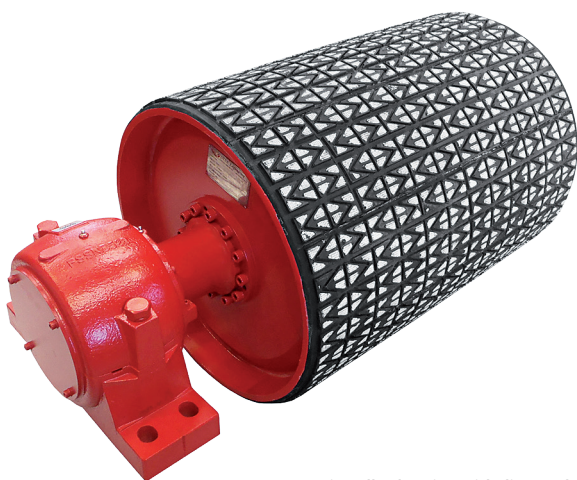
*DYNA ceramic pulley lagging with diamond grooves.*

to significantly reduce the risk of the lagging separating from the shell. Lagging is then machined to a smooth, blemish free surface. It is typically grooved with a 120-degree diamond pattern to assist with the dispersion of mud and water.

Another common type of pulley lagging is ceramic. Harsh conditions and abrasive material are the two usual reasons why ceramic lagging is considered. The most common types of ceramic lagging are 'smooth' and 'dimple'. Both of these products offer a significant increase in friction, grip and tracking of the belt, and elimination or reduction of belt slippage.

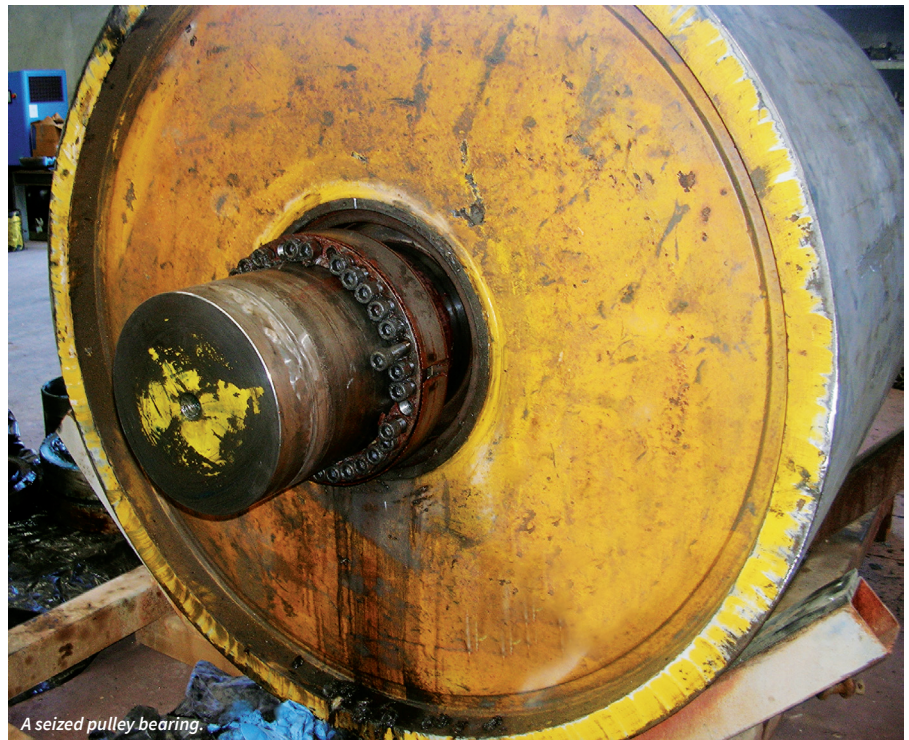
A seized pulley bearing.

Seized bearings can be caused by lack of grease, old age, fatigue, product build-up and other factors. They will cause the rotation of the pulley to malfunction. This can lead to a multitude of issues for your entire conveyor operation. Proper maintenance procedures and inspections leading to refurbishments will help avoid further serious and expensive consequences.

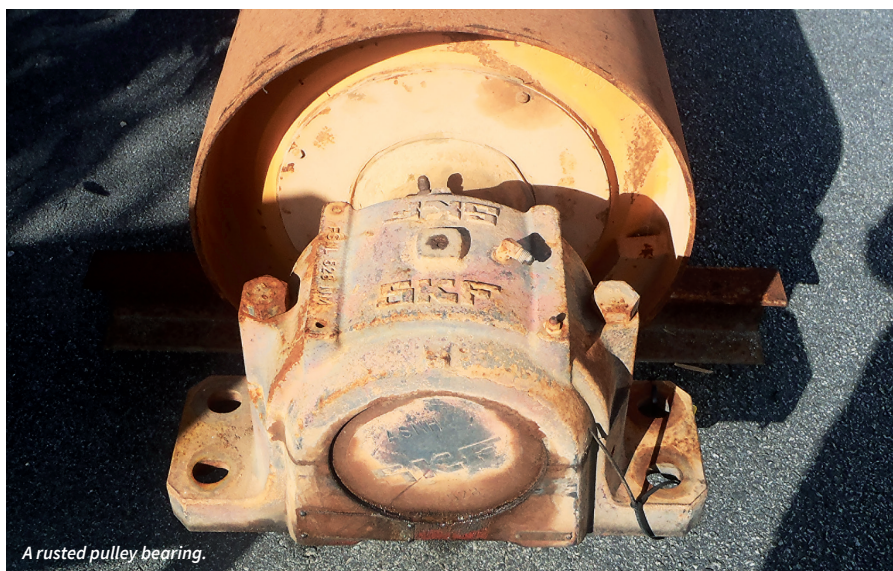
A rusted pulley bearing.

Over time, pulley housings and bearings will naturally rust or corrode. While slight rusting or fading is not necessarily a huge concern, badly degraded pulley elements may indicate the need for complete replacement. Heavily worn bearings and housings can lead to seizures and breakdowns. Preventative maintenance and regular inspections will assist in avoiding such problems.
